**AVANTech's Desludging and Water Processing Efforts in Support of the Enrico Fermi Power Plant 2 Torus Recoat Project – 21224**

Mark Ping \*, Larry Beets \*, Robert Denne \*  
\* AVANTech, LLC

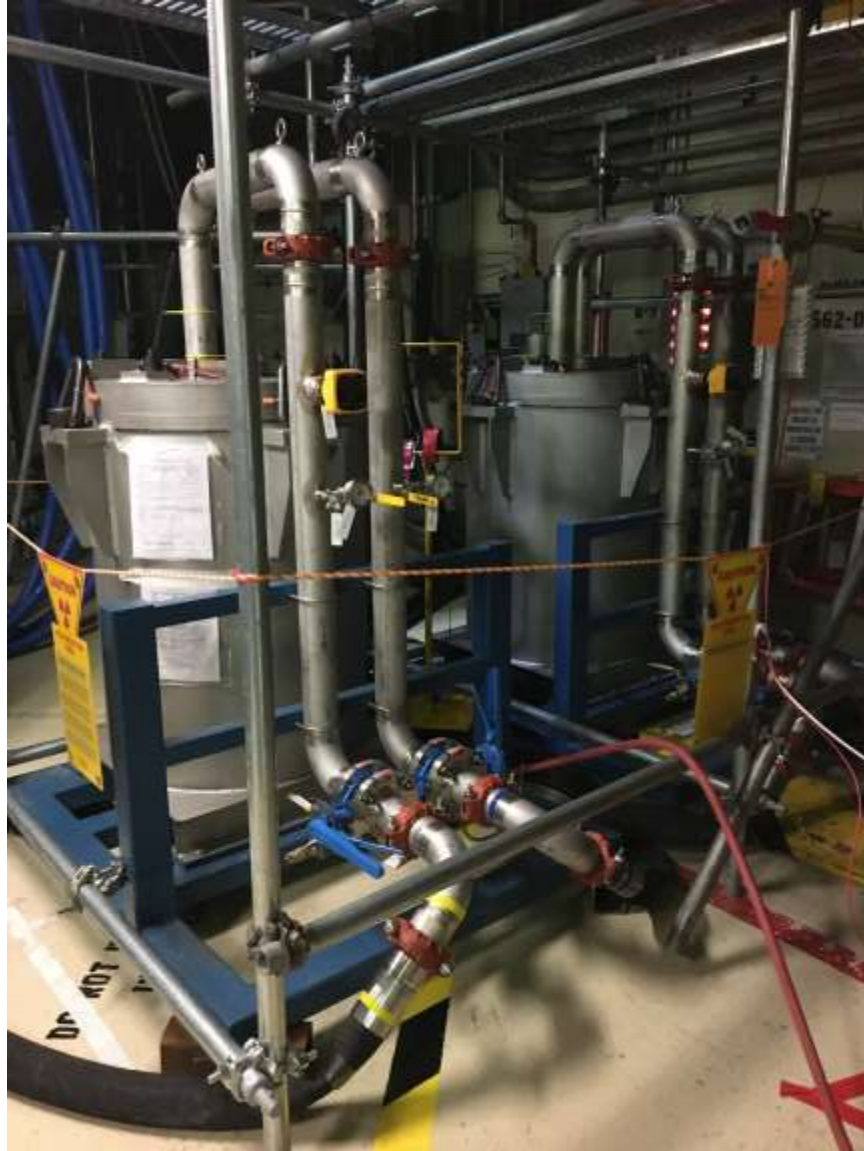
Fig. 1. Reactor Building, SW Basement, Torus Filtration Setup

AVANTech has been providing filtration systems in support of torus/suppression pool cleaning and inspection at various nuclear power plants for over a decade. The Fermi project presented some unique challenges to the normal way of filtering pool water, which typically would include a high flow submersible pump capable of 1,893-2,839 lpm (500-750 gpm) and a set of fully contained filter canisters inside a 3.4 m<sup>3</sup> (120 ft<sup>3</sup>) liner inside a shielded cask with 15-cm (6-in) supply and return lines. The challenges included:

- Lack of adequate space for the normal system – AVANTech had to be able to fit the filtration part of the system in the southwest basement of the reactor building (Residual Heat Removal (RHR) quad).
- The need to run hoses across the top of the torus from the northwest hatch to the southwest vent duct, as well as back to each of five building sumps – Over 975 m (3,200 ft) of hosing was manufactured, tested, and installed for this portion of the project (normally the hosing would have run in and out of the northwest hatch).

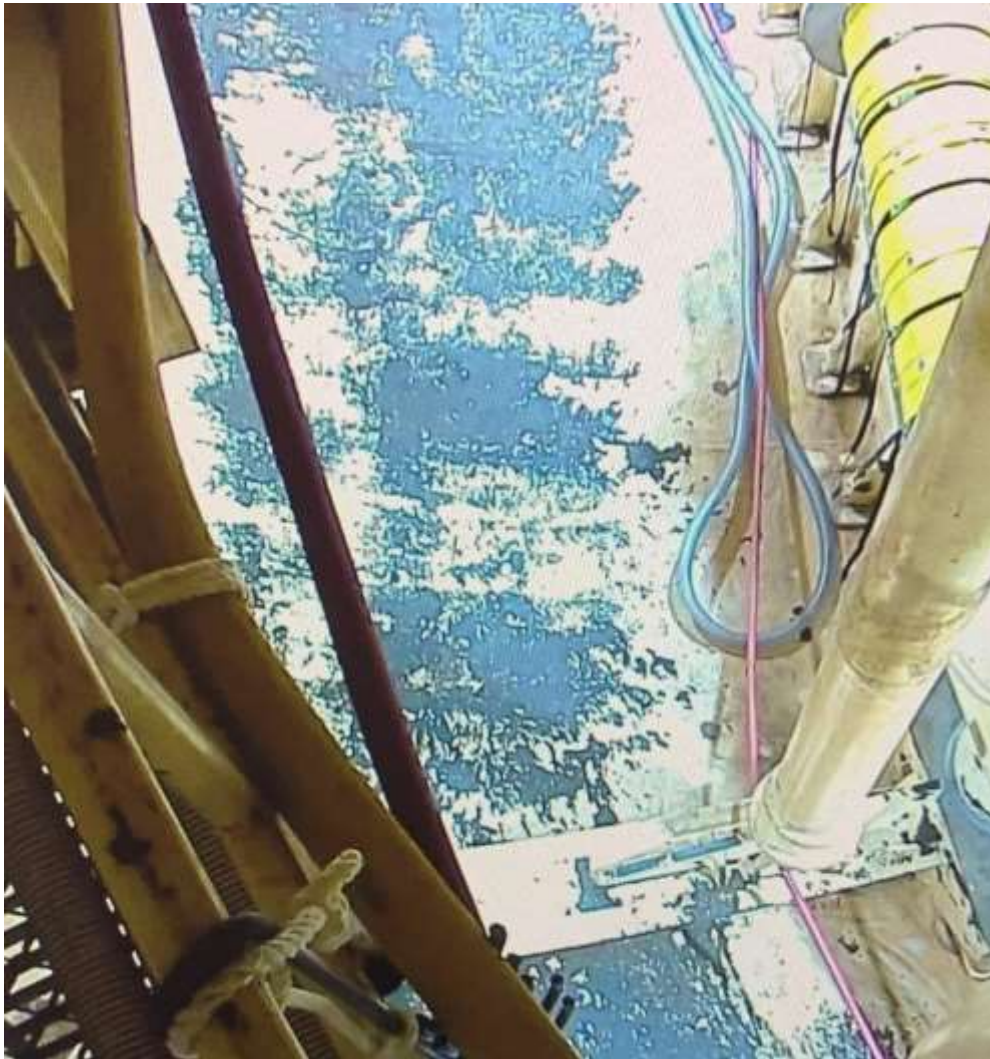
Fig. 2. Computer Monitor Screen Shot of Torus Prior to Blasting

Watching the diver cameras, it was easy to see that this increased and unexpected dose came from more aggressive hydrolasing activities releasing pockets of high activity and dose from blistered paint and from the down-comers.

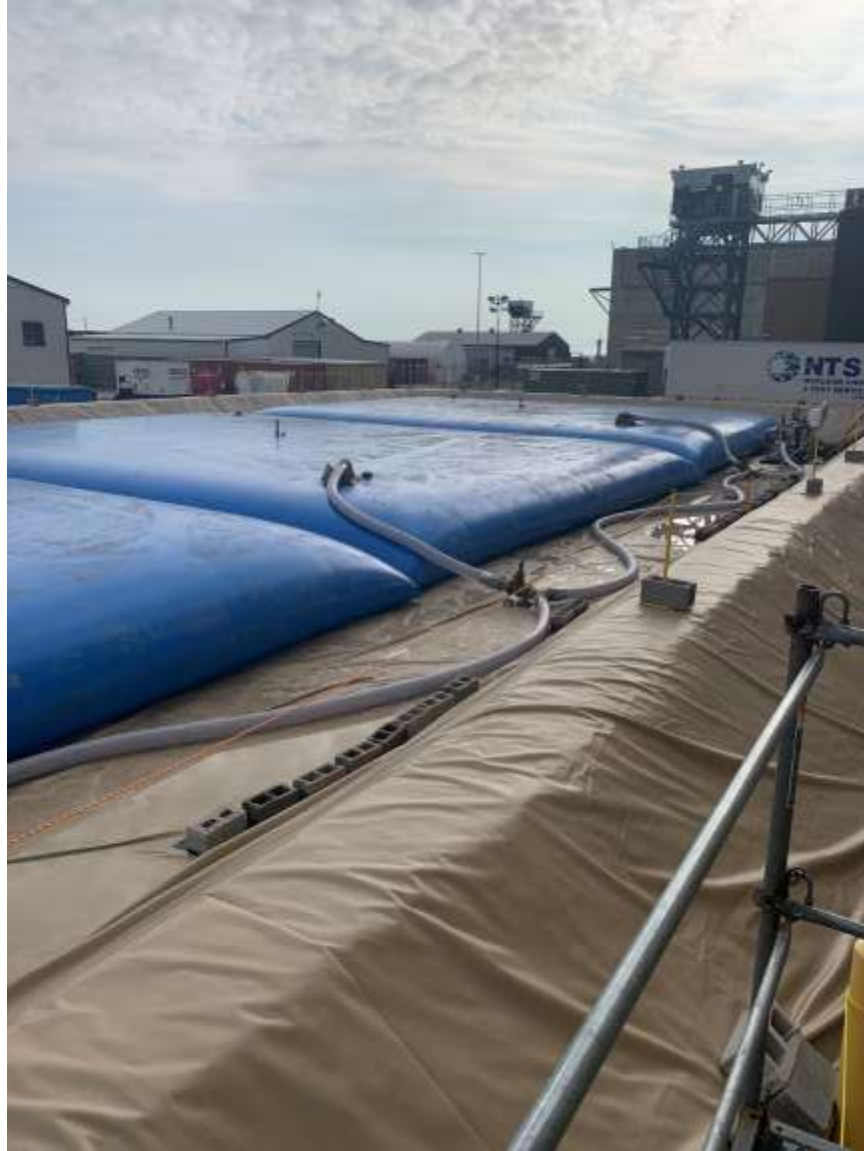
Fig. 3. Torus Water Storage Post-Filtration

AVANTech modified its WPS cargo container to accommodate the movement and cleaning of the anticipated  $8.1e-4$   $\mu\text{Ci/cc}$  water from the torus to the outside bladder bags and the CST/CRT. The WPS cargo container was designed to capture torus water activity prior to that water going to the bladder bags for storage outside of the north side of the reactor building. The bladder bags were housed in a specially designed berm to handle 110% of its designed capacity.

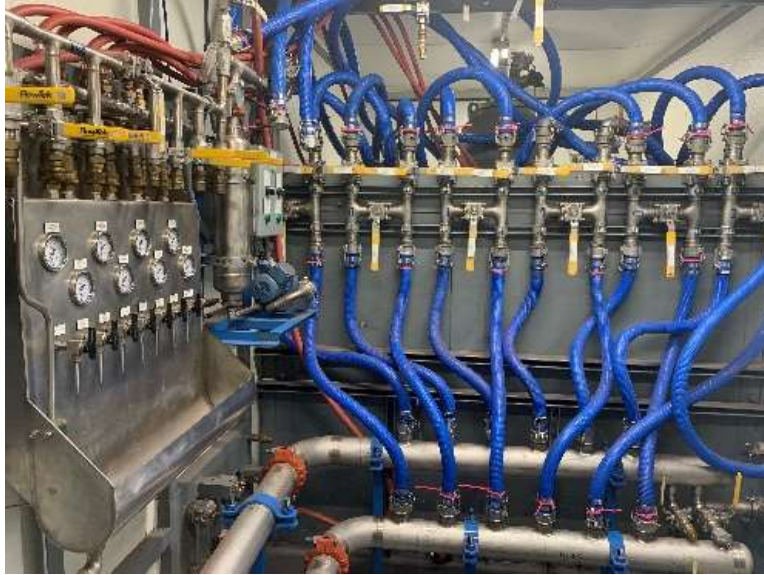
Fig. 4. WPS System Manifold System

As noted above, AVANTech designed this part of the system to capture water with an activity of  $8.1 \times 10^{-4}$   $\mu\text{Ci/cc}$ . Calculations indicated that no more than about 24 mRem/hr at 30 cm (12 in) from the outside of the cargo container housing the vessels would be encountered. The system was designed so that there was enough resin available to allow for processing of well over 3,785,000 L (1,000,000 gal) of torus water at the Chemistry-specified activity. Approximately 1,968,400 L (520,000 gal) went through the system and out to the bags and to the CRT/CST. Because it was expected that nearly all the particulate would be captured in the first phase of the operation (diver non-abrasive cleaning), there was no mechanical filtration designed into the WPS system either before or after the ion-exchange resin vessels. To minimize weight during transport and maximize processing capabilities, the WPS cargo container had no added shielding in its design. The cargo container could have supported the addition of shielding on its outer surface once installed in the plant. The plant opted to install shielding on scaffolding, exterior to the container.

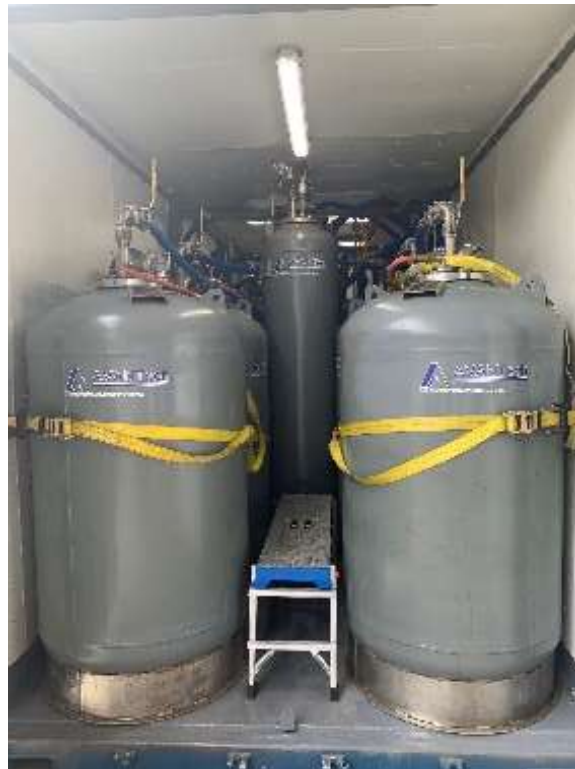
Fig. 5. WPS Ion Exchange Vessels

As water levels were being lowered in the torus, personnel were washing down the sides of the torus, with that water then being sent through the TWMS system to the vessels and out to the bags. As more and more water was sent from the torus to the bags, dose rates on the resin vessels began to climb significantly above what was initially expected. Final vessel dose rates were on the order of 600 to 1,000 mRem/hr on contact.

- A failure of one of the vessel laterals allowed resin to escape that vessel and be captured by a mechanical resin trap prior to exiting the WPS cargo container. The mechanical trap performed as designed. After a long period of trouble shooting, it was determined that the dewatering laterals in ion exchange vessel 1 had been breached. That vessel was isolated from the system. Because the system was conservatively designed, the loss of one vessel had no major effect on the overall water quality produced. It is AVANTech's opinion that the breach occurred during transport of the cargo container from Tennessee to Fermi. Had the breach occurred prior to that, it would have been discovered during the loading of resin in the vessel. The resin was loaded in the vessels by vacuuming. Had the vessel laterals been damaged at that point, resin would have come right back out as it was being put in. Overall delay due to the failure of the vessel laterals was approximately 36 hours.
